EXTERIOR CONDITIONS MEMO

Cable Car Barn

San Francisco Department of Public Works | September 2021

Cable Car Barn Exterior Conditions Memo

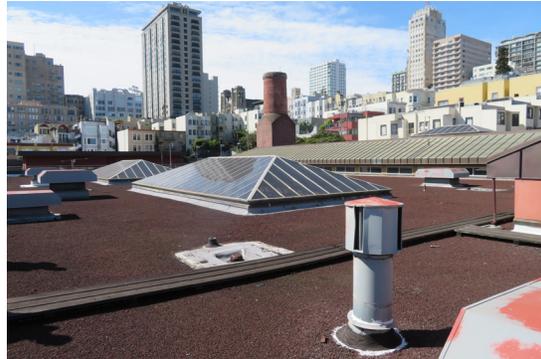
- Condition of the built-up membrane roof is obscured by aggregate, but assumed to be in overall fair to poor condition. Membrane has likely reached the end of its useful life. Evidence of past roof patching or selective replacement was noted.

Built-up roof with red aggregate

- Replace membrane roof and all related flashing. Remove and replace all sealant joints.
- Remove all tree litter and debris from roof and ensure drains are kept clear.

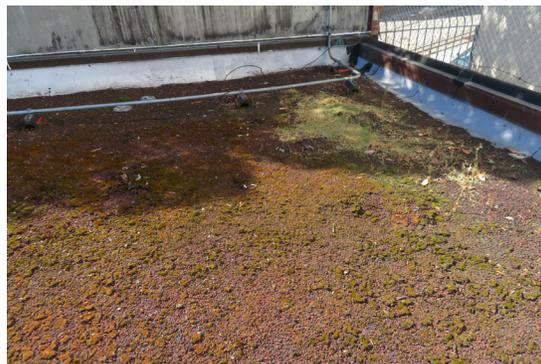
- Membrane is covered in heavy biological growth at one location on the south side.
- Standing seam metal roofs were observed from the perimeter and appear to be in overall fair condition.

Roof covered in heavy biological growth on the south side

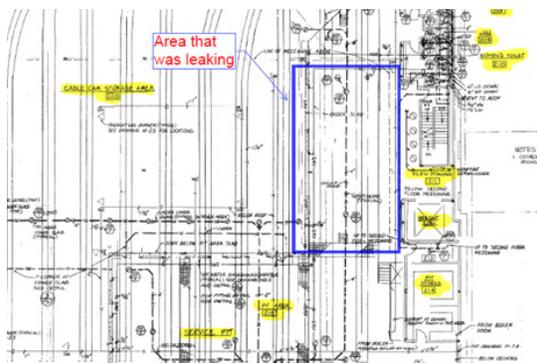
- Sealant joints at sheet metal flashing are deteriorated and in poor condition.
- SFMTA representatives reported a water leak in 2020 near/at the pit on the second floor (area marked in blue on the next page) and suggested the leak may be due to a pipe failure or the condition of the concrete. One pit has since been resealed, however it is not known if the leak has been resolved. ARG was not informed of the leak until after the site visit, however ARG did not observe any signs of major damage on the roof area immediately above the location besides deteriorated sealant and detached flashing. If the leak is still active, further investigation or testing may be needed to identify the source.

Water leak near/at the pit on the 2nd floor in 2020
(Image credit: MTA)

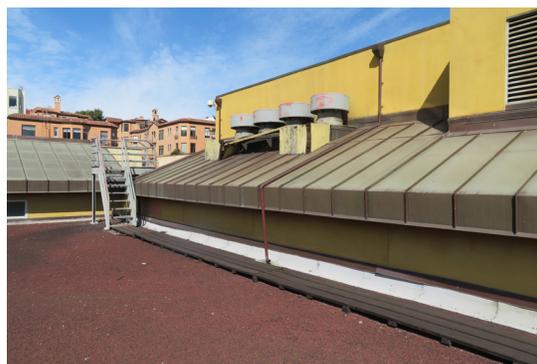
Area immediately above the reported water leak

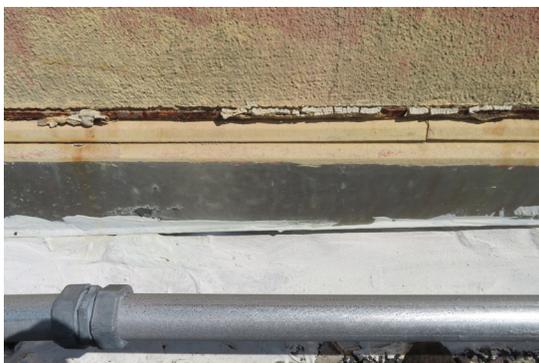
Deteriorated sealant and corroded metal above the flashing at the roof parapet

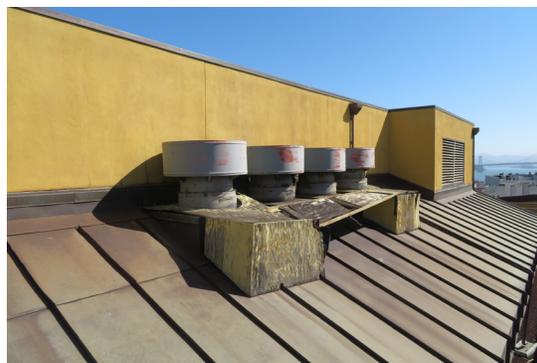
Area immediately above the reported water leak

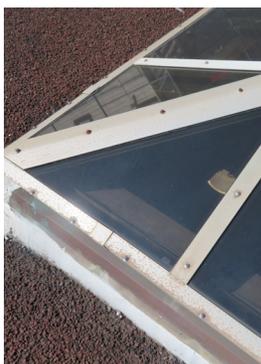
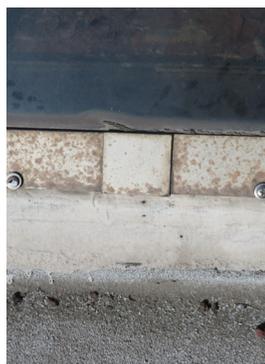
Mild corrosion and weathered finish

- Clean and refinish the skylight frames. Remove and replace all sealant joints. Inspect and touch-up all sealant joints every 3 to 5 years.
- Repair the detached flashing at the ground-floor skylight. Replace the deteriorated sealant.

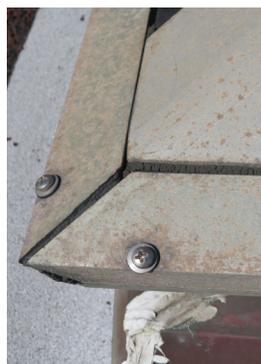
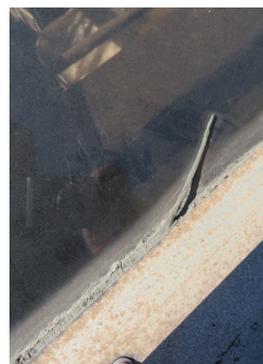
Mild corrosion, weathered finish, and deteriorated sealant

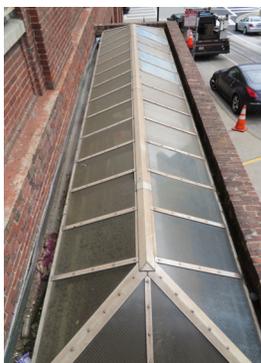
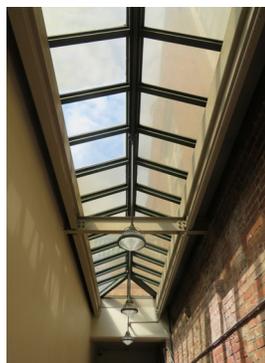
Detached flashing at the ground-floor skylight

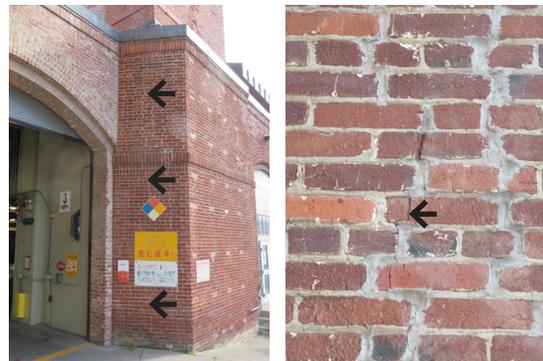
- Brick masonry is in fair condition and exhibits multiple cracks, spalls, and open or deteriorated mortar joints.
- A full-height hairline-size crack on the south elevation runs through brick units and mortar joints.

Full-height crack, south elevation

- Repair cracks and spalls in the brick masonry. Visually monitor large and long cracks after the repair. If any of the cracks open up again, it may indicate an area of active movement.

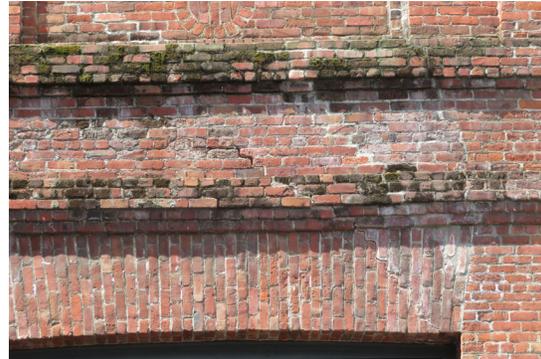
Stepped crack through mortar joints, east elevation

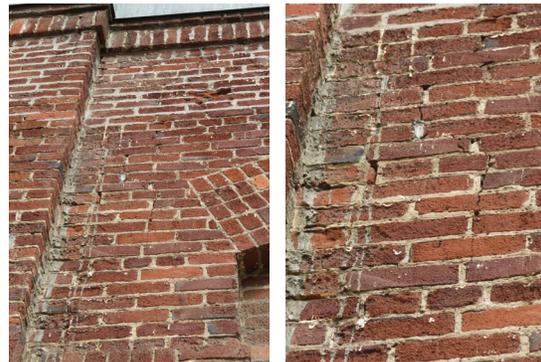
Stepped crack, south elevation

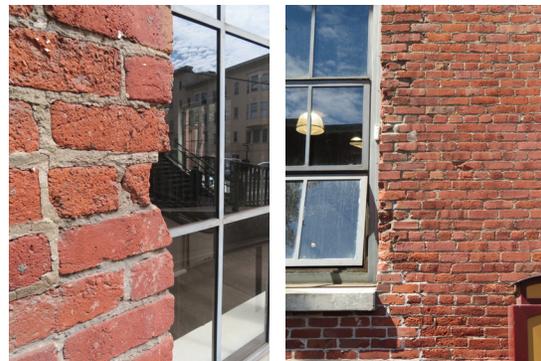
Spalled bricks around the windows, south elevation (left) and east elevation (right)

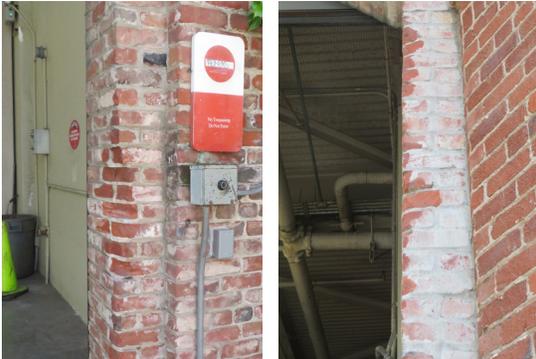
Spalled bricks around the building entrances, north elevation (left) and south elevation (right)

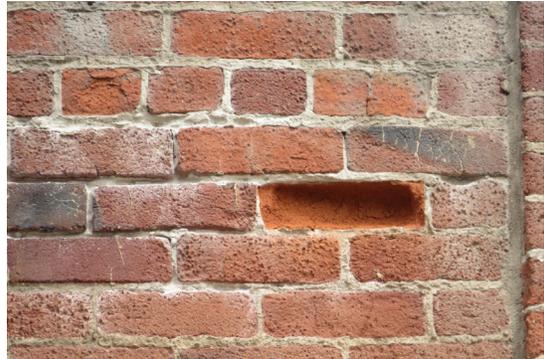
Spalled brick, south elevation

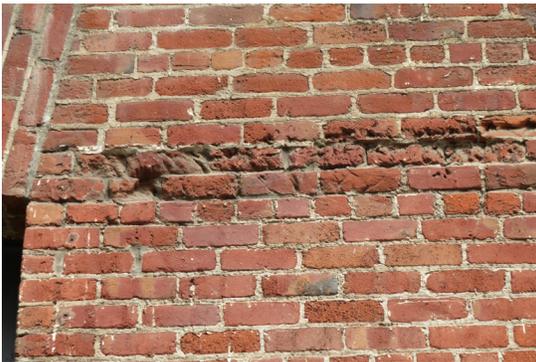
Damaged bricks, south elevation

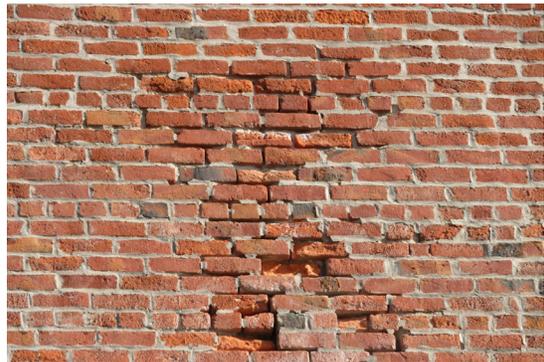
Spalls and open joints in the brick chimney, south elevation

- Repoint open or deteriorated joints in the brick masonry.
- Consider replacing poorly matching masonry repairs and mortar joints for aesthetic reasons. Matching new or replacement brick to the existing abraded brick will require extra care.

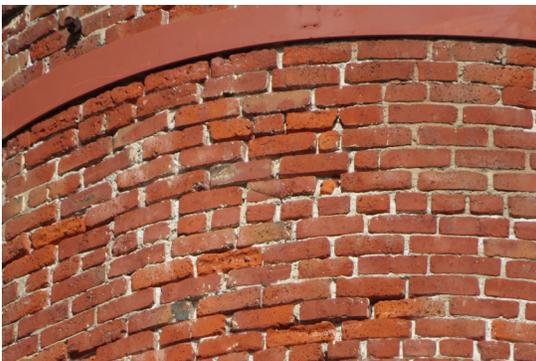
Spalls and open joints in the brick chimney, south elevation

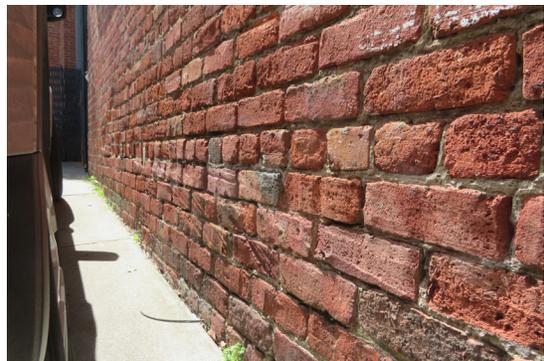
Open joints

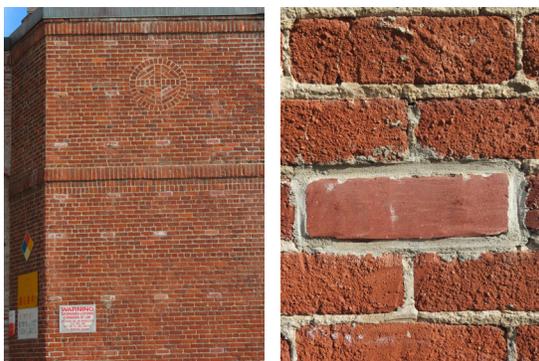
Non-matching mortar joints around brick replacements, south elevation

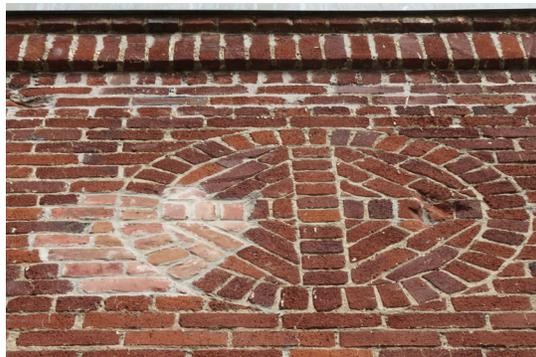
Non-matching brick replacements, south elevation

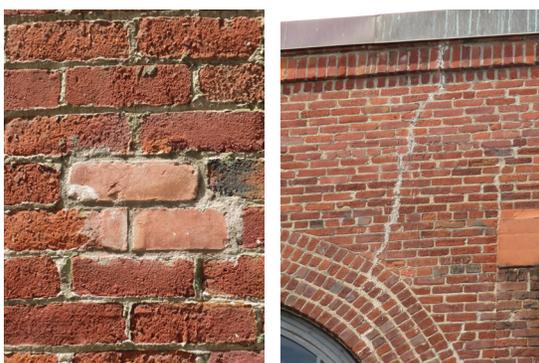
Non-matching repairs, east elevation

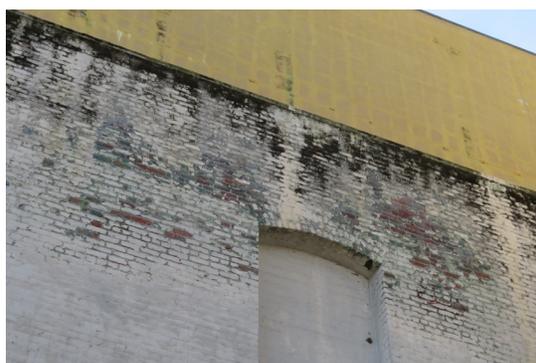
- Plant beds are overgrown on the south elevation.
- Brick masonry is painted on the north elevation. The paint is in fair to poor condition. It is flaking and peeling at several locations and also covered in general soiling and biological growth at the parapets.

General soiling, biological growth, and paint deterioration, north elevation

- Repair leaking pipes on the east elevation.
- Trim overgrown plant beds and remove unwanted plant growth/weeds.
- Prepare, prime, and paint the brick masonry at the north elevation.

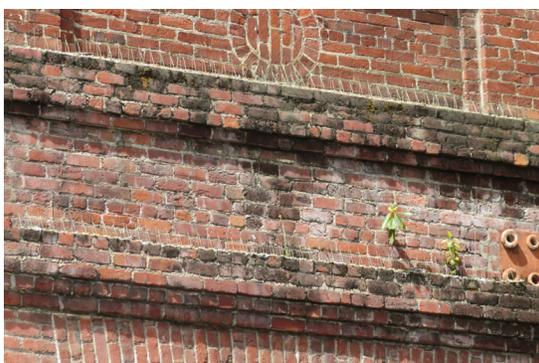
General soiling, biological growth, efflorescence, and plant growth, east elevation

- Clean masonry to remove general soiling, biological growth, efflorescence, and stains. Consider installation of coating or sloped parge coat on skyfacing masonry surfaces like belt courses to shed water.

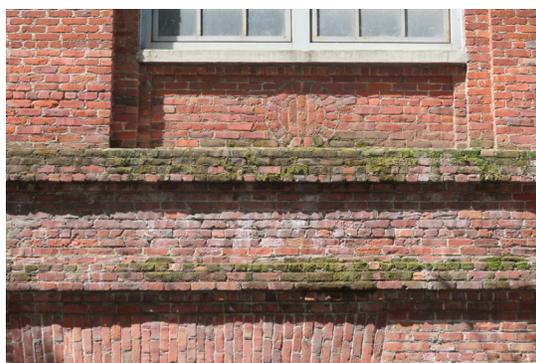
Biological growth, efflorescence, and open/deteriorated mortar joints, east elevation

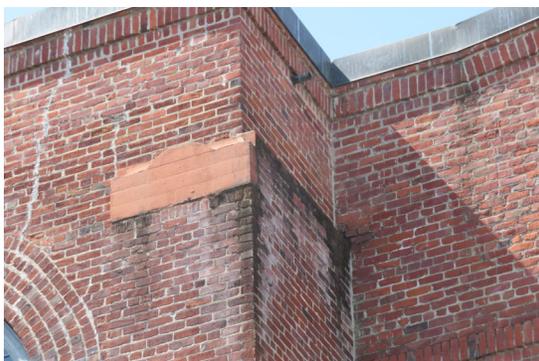
Heavy general soiling and biological growth near overflow scupper, east elevation

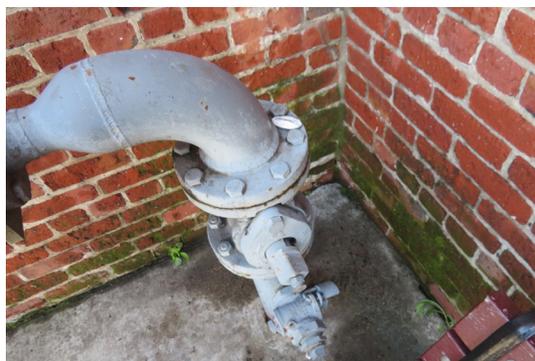
Leaking pipes resulting in biological growth, east elevation

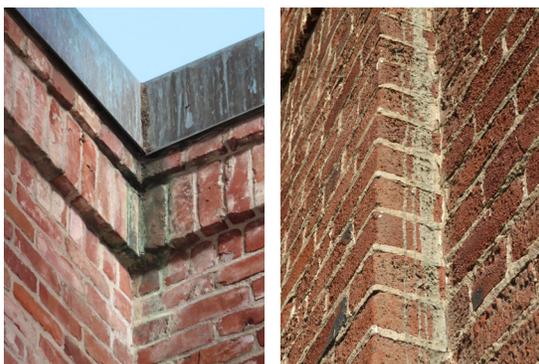
Copper stain (left) and mortar slurry residue (right), south elevation

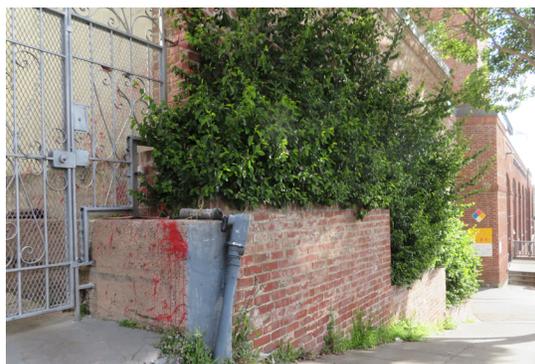
Overgrown plant beds and weed growth, south elevation

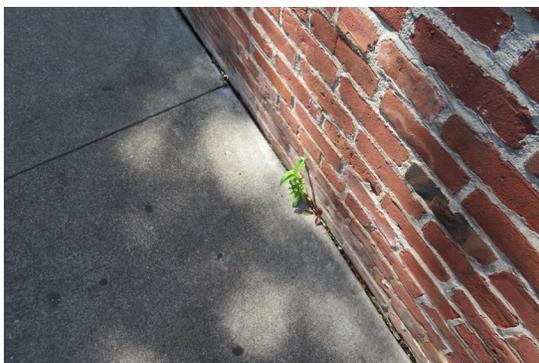
Open joint at the base of the building, east elevation

- Install sealant joint at the base of the building.
- Replace or repair metal parapet coping. Repair may include installation of an extruded silicone seal at joints.

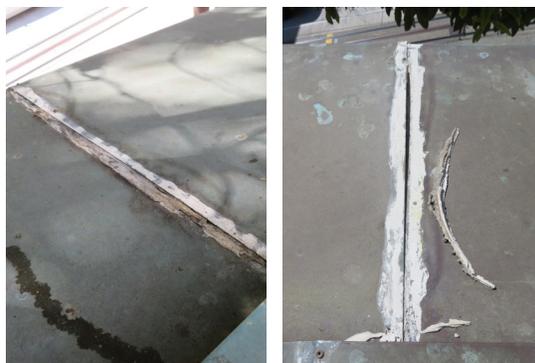
Deteriorated sealant at metal coping

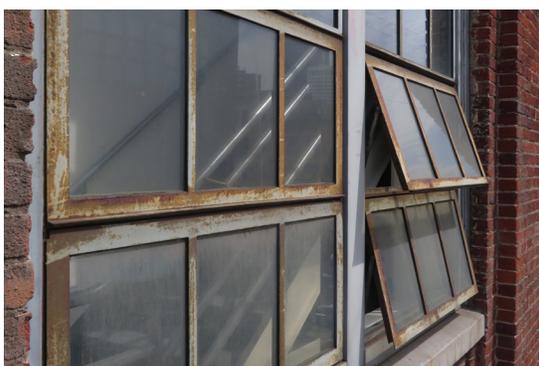
Corrosion on the windows

- Replace cracked glass panes to match existing in color, texture, size, and thickness.
- Replace missing or damaged hardware.
- Clean, adjust, or lubricate all sashes to make them easier to operate.
- Install new perimeter sealant at all windows.
- Prepare, prime, and paint all windows.

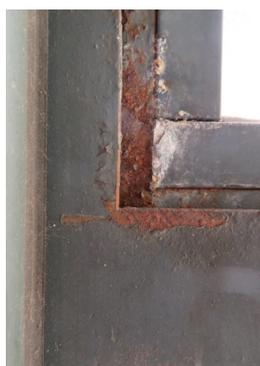
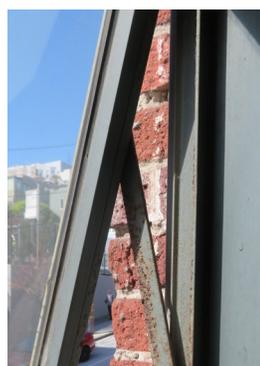
Corrosion on the windows

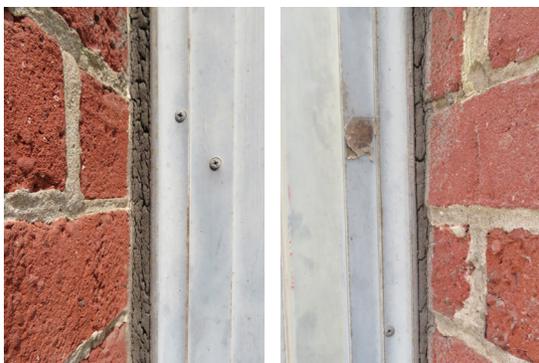
Deteriorated perimeter sealant

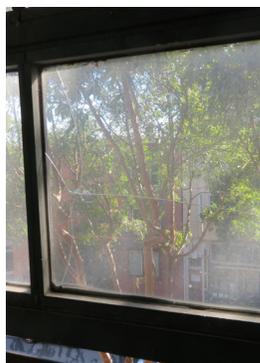
Cracked glass (left) and missing lever (right)

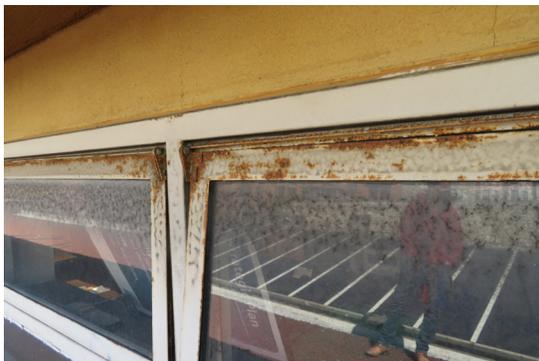
Corrosion

- Clean, adjust, or lubricate all sashes to make them easier to operate.
- Install new sealant at all windows and flashing.
- Prepare, prime, and paint all windows.
- Prepare, prime, and paint the plaster. Before painting, sound and replace all cracked and loose plaster. New plaster to match the texture of the existing plaster.

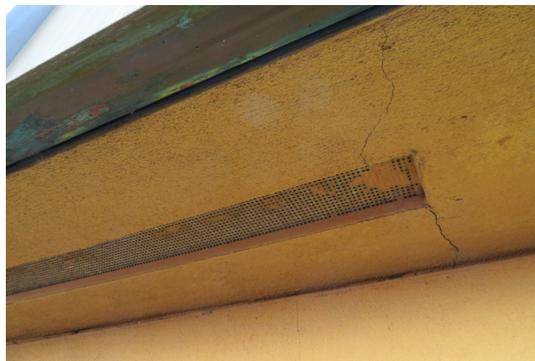
Cracks in the plaster

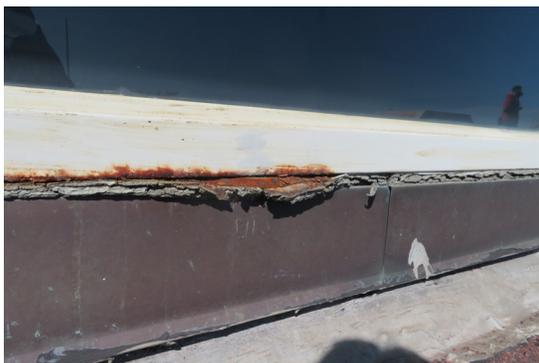
Deteriorated sealant at the flashing

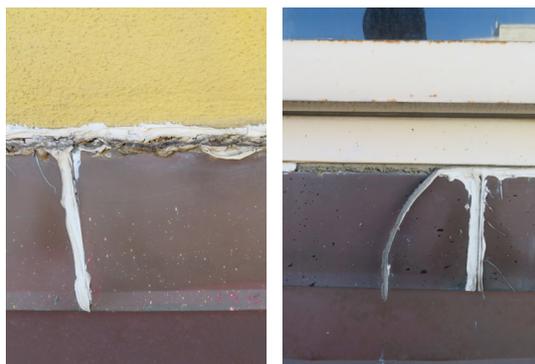
Deteriorated sealant at the flashing

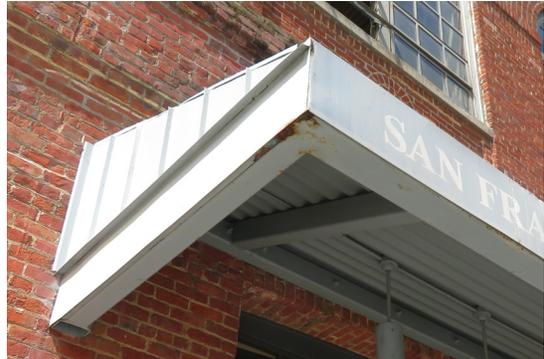
Corrosion at the museum entrance canopy

- Clean, adjust, or lubricate all doors to make them easier to operate.
- Install new perimeter sealant at all door surrounds.
- Prepare, prime, and paint all metal door and entrance canopy components.
- Clean and refinish all wood doors.

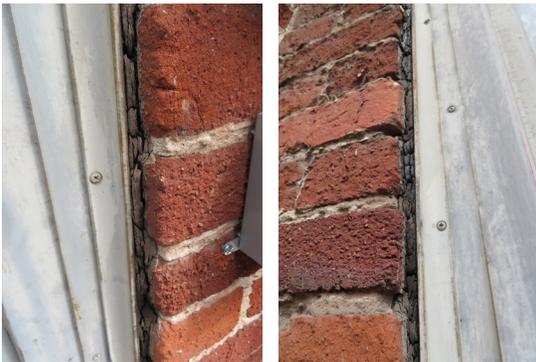
Deteriorated perimeter sealant

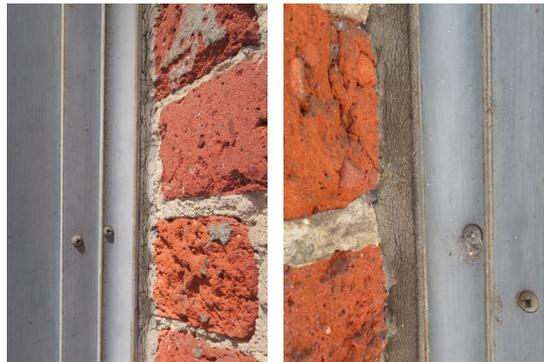
Deteriorated perimeter sealant

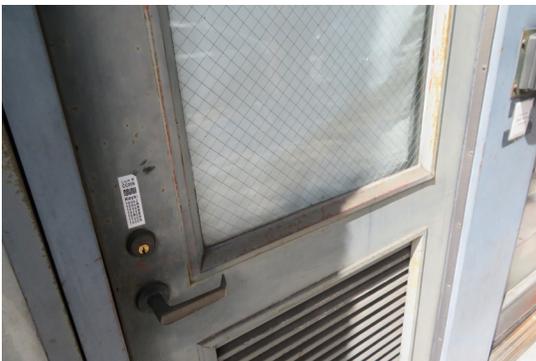
Mild corrosion and weathered finish

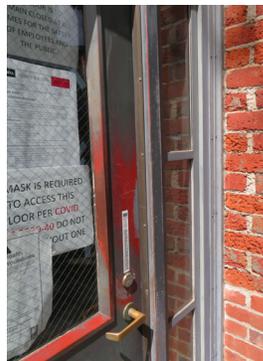
Mild corrosion and weathered finish
