Cable Car Barn Rehabilitation Project Update

SFMTA Citizens' Advisory Council (CAC)

March 24, 2024

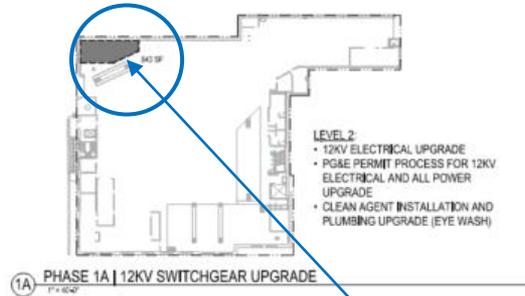
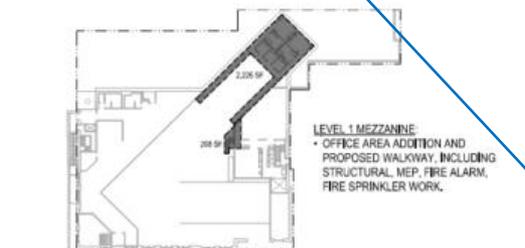
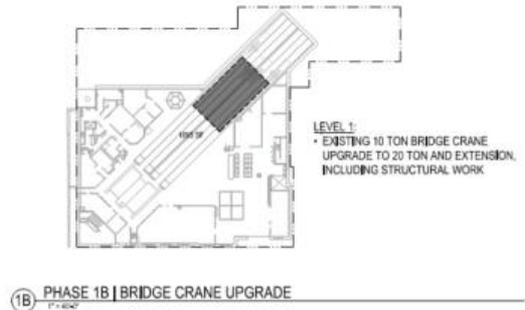
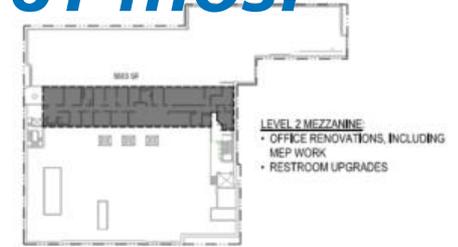
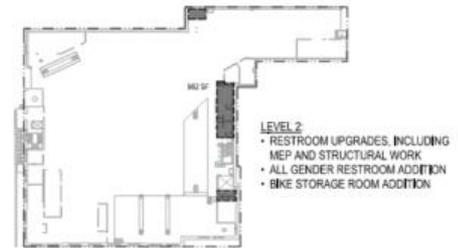
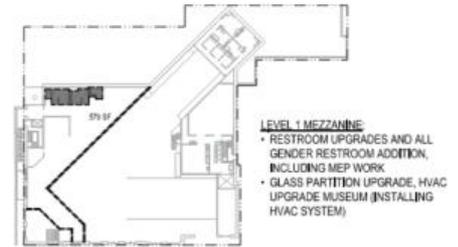
MP Phasing Plan (Phases 1 thru 5) 61 mos.

- Level 2: 12kV electrical upgrade. PG&E permit process for 12kV electrical and all power upgrade. Clean agent installation and plumbing upgrade (eye wash)

- Level 1: Existing 10-ton bridge crane upgrade to 20-ton and extension, including structural work
- Level 1M: Office area addition and proposed walkway, including structural, MEP, fire alarm, fire sprinkler work.

- Level 1: Restroom, locker and office upgrades, including MEP work. Upgrade fire suppression system (remove halon system)
- Level 1M: Glass partition upgrade, HVAC upgrade museum (installing HVAC system), restroom upgrades, including MEP work.
- Level 2: Restroom upgrades, including MEP work. Bike storage room addition
- Level 2M: Office renovations including MEP work
- All levels: Passenger and freight elevator upgrades, including structural work for guide rails (all levels)

- Level 1: Reallocation of weld room and new inspection room. Existing machine shop, pulley assembly area and steam cleaning/weld area upgrade. 2-ton bridge crane addition. MEP work.
- Level 1M: Compact storage including structural work
- Level 2: Reallocation of grip building area from level 1, including MEP work.

- Level 2: Carpentry and office area upgrades including paint booth and spray booth Demolition of existing break room on upper level. MEP work. replace heating units in inspection pits

- Remaining MEP upgrade, new skylights and entire roof replacement

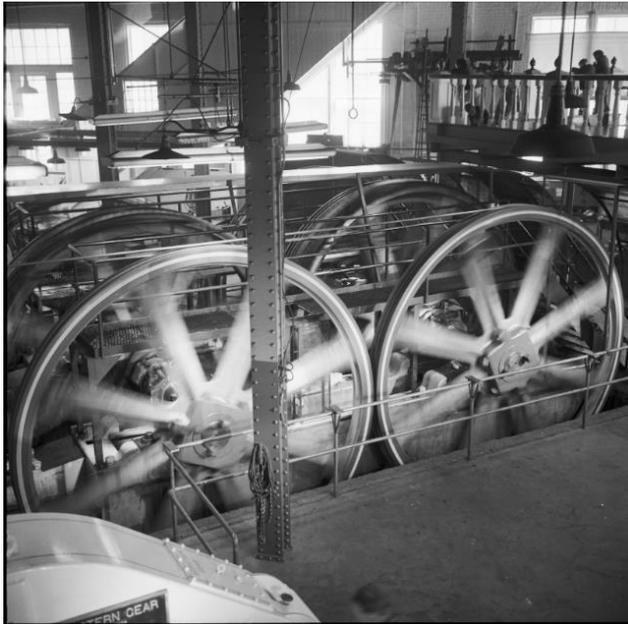
Cable Machinery Winding Wheels, 1970
SFMTA Photo Archives M0817_1

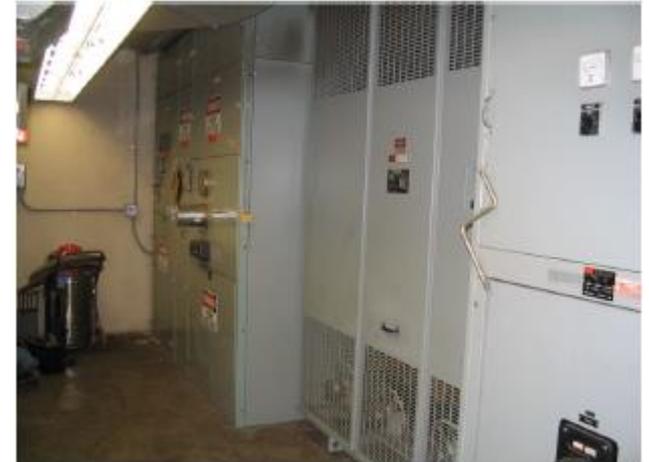
*Medium Voltage Service Entrance Switchgear, 2.5 MW
Medium Voltage Transformer and 480 V Switchboard*

- Main Medium Voltage Service Entrance Switchgear
- Medium Voltage Transformer
- Low Voltage Switchboard
- AC and DC Electrical Panel
- Remote Terminal Units (RTU) and Supervised Control and Data Acquisition (SCADA)
- Transfer Switch and Emergency Generator Hookups

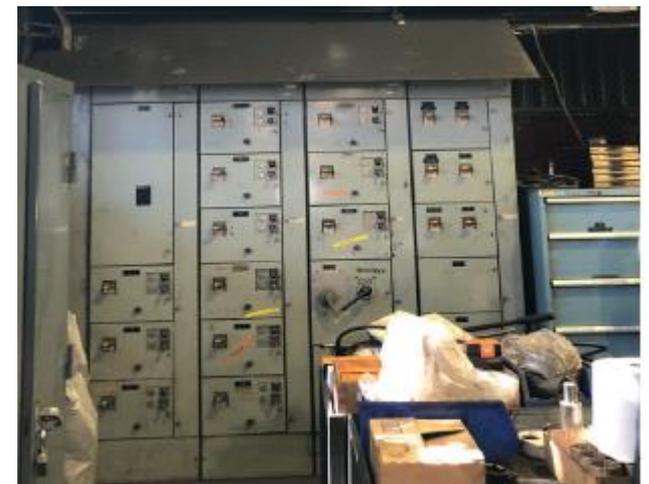
Motor Control Center (MCC)

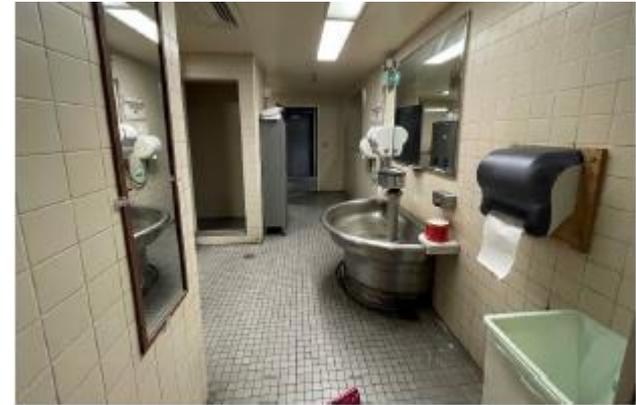
Non-compliant lavatory and shower (Men 203).

- Path of Travel Widening
- Doorway Widening
- Restroom Accessory Replacement
- Wayfinding Signage
- Locker and Office Space Renovations
- Entrance Ramp and Landing Slope Softening
- Handrail Refurbishment

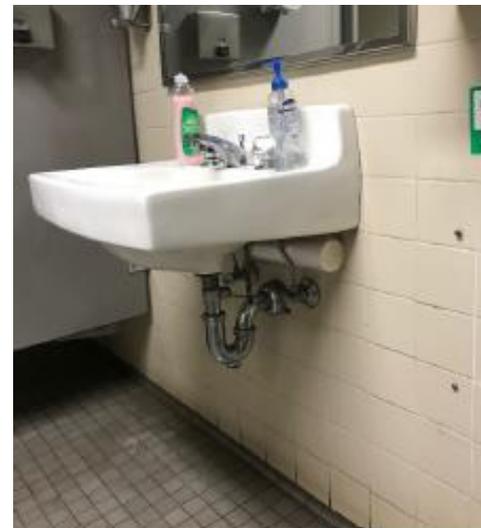
Non-compliant lavatory (Women 106).
