## Access path symbol key\*

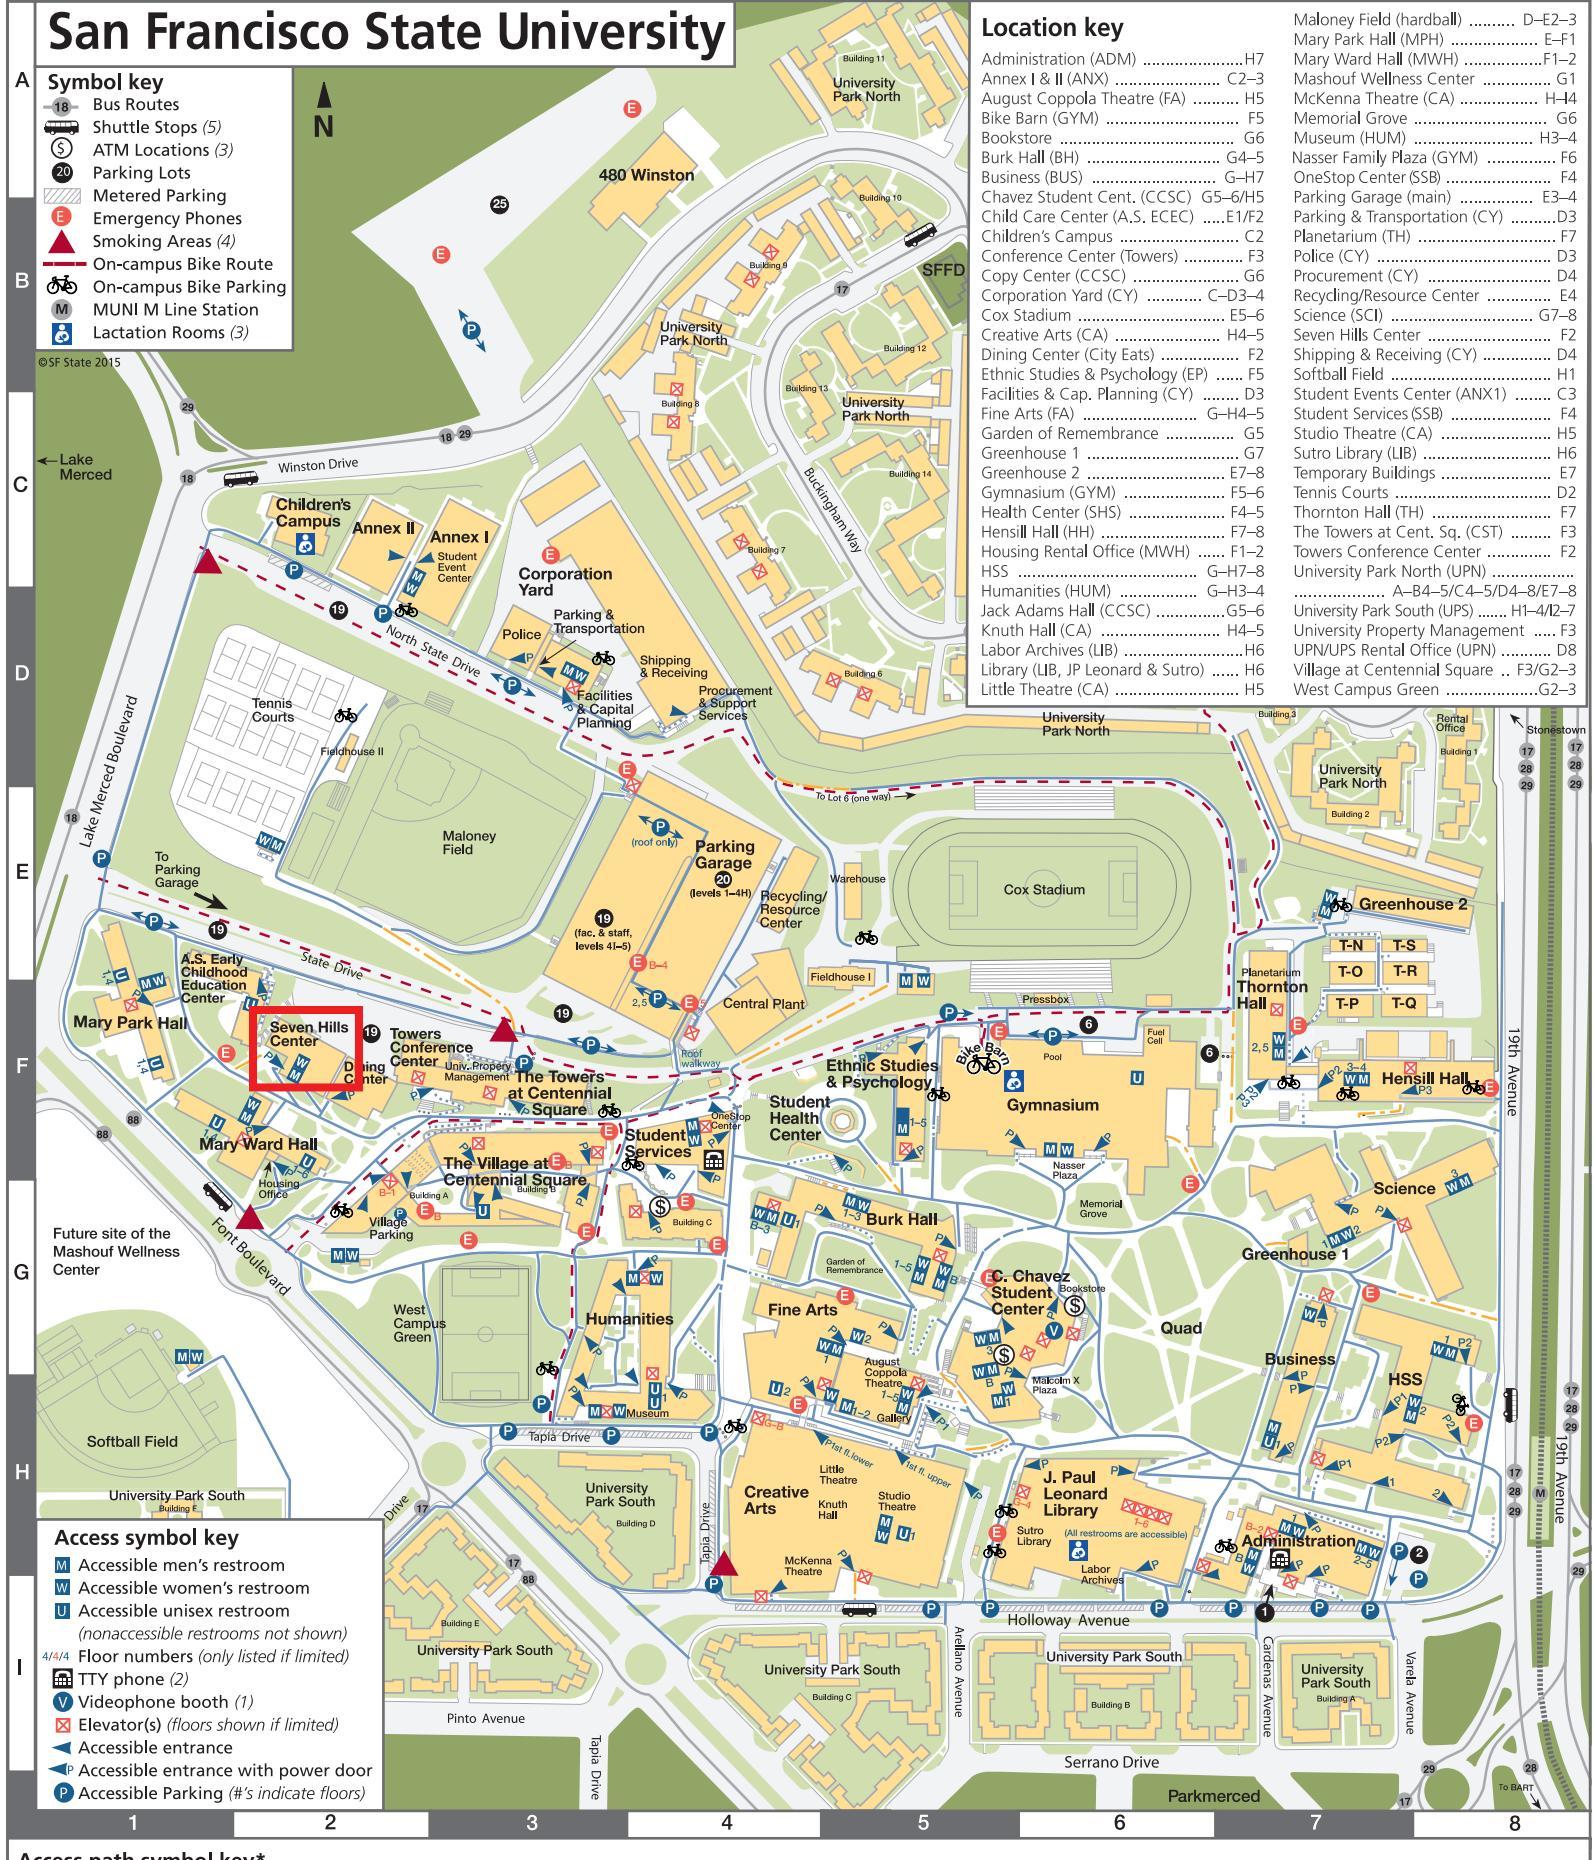
Accessible Route—This path generally conforms to accessibility standards.
 Areas that may be a travel hazard (where the slope exceeds the standard maximum ramp slope [8.3%], or the cross-slope is significant [exceeds 4%]).

Partially Accessible Route—This path generally conforms to accessibility standards, but there
may be excessive cross-slope (over 2%) or other irregularities in a portion of the path, often
along the path edge. There is usually a 48" wide complying path along these routes, though
it may not be a straight or direct line.

Lighter shade indicates path continues underneath overhang.

\*Note: The map and information on pathways are limited by the scale. The accessible route should be clear to a person at a location, while the dashed line is intended to indicate where keener observation may be necessary to locate the accessible route. Pathways are generally asphalt and subject to weathering, erosion, uplifting, and other changes that may create navigational issues. SFSU is committed to maintaining the accessible route. Please report any irregularities to Disability Programs and Resource Center, 415-338-2472 (voice, TTY).
