EXTERIOR CONDITIONS MEMO

Cable Car Barn

San Francisco Department of Public Works | September 2021

Cable Car Barn Exterior Conditions Memo

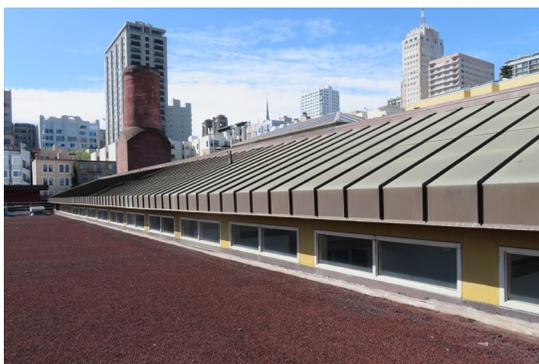
Sheet copper roof at the clerestory

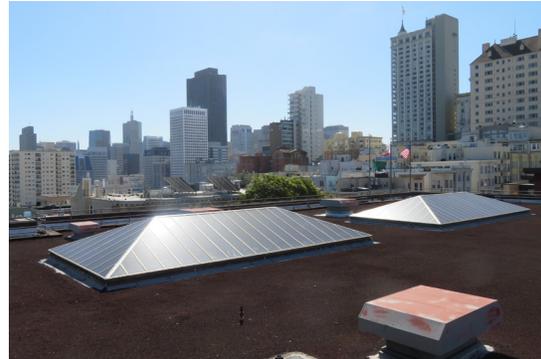
- Skylights are in fair condition and exhibit mild corrosion, weathered finish, general soiling, and sealant failure.
- At the ground-floor skylight, the sheet metal flashing on the adjacent wall is detached and has deteriorated sealant.

Roof skylights

- Clean and refinish the skylight frames. Remove and replace all sealant joints. Inspect and touch-up all sealant joints every 3 to 5 years.
- Repair the detached flashing at the ground-floor skylight. Replace the deteriorated sealant.

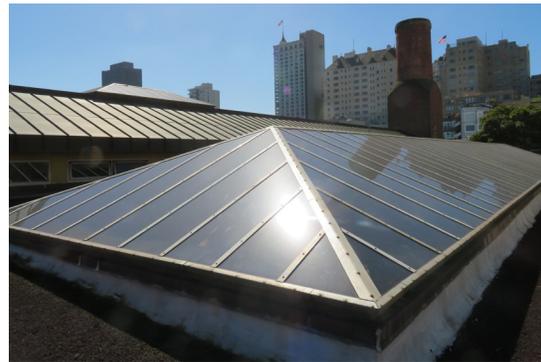
Roof skylight

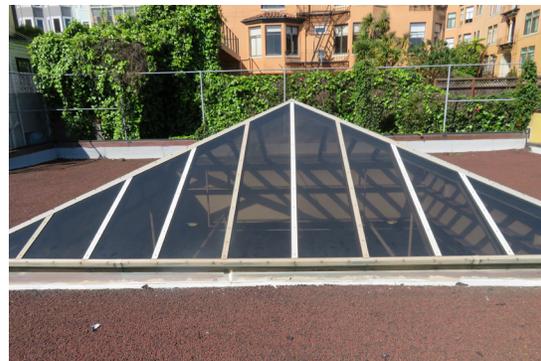
Roof skylight

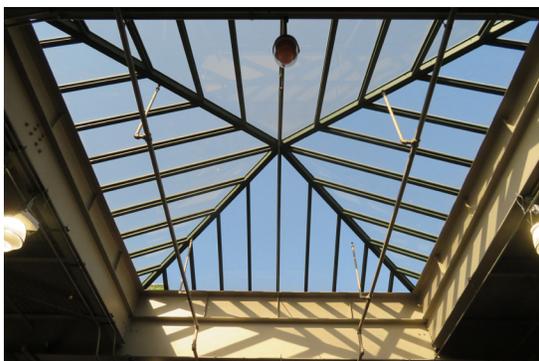
Roof skylight, view from below

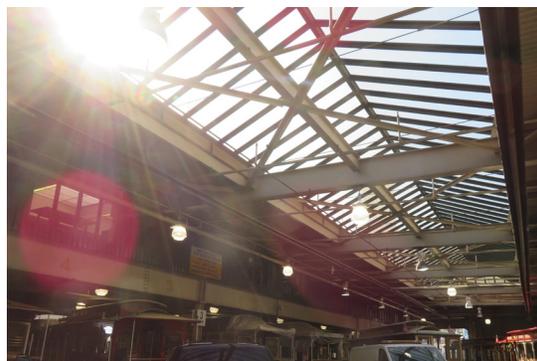
Roof skylight, view from below

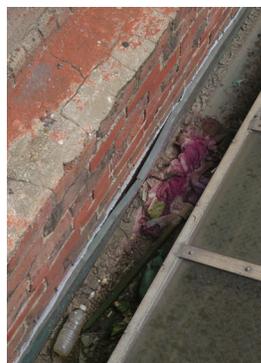
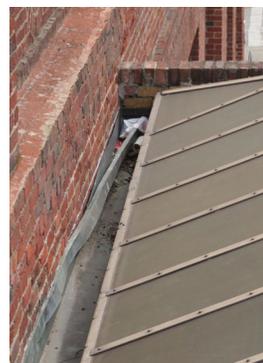
Detached flashing at the ground-floor skylight

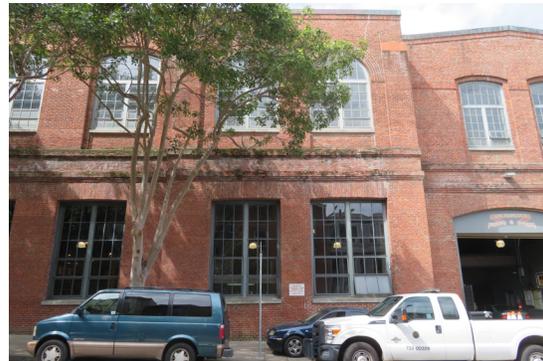
East elevation

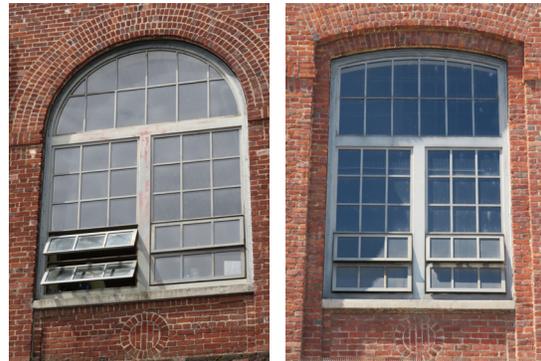
Second-floor multi-lite steel windows

- Replace cracked glass panes to match existing in color, texture, size, and thickness.
- Replace missing or damaged hardware.
- Clean, adjust, or lubricate all sashes to make them easier to operate.
- Install new perimeter sealant at all windows.
- Prepare, prime, and paint all windows.

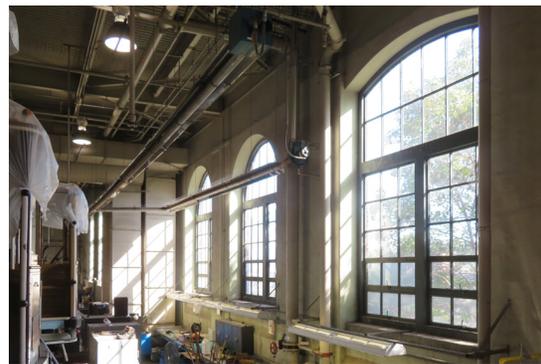
Second-floor multi-lite steel windows, interior view

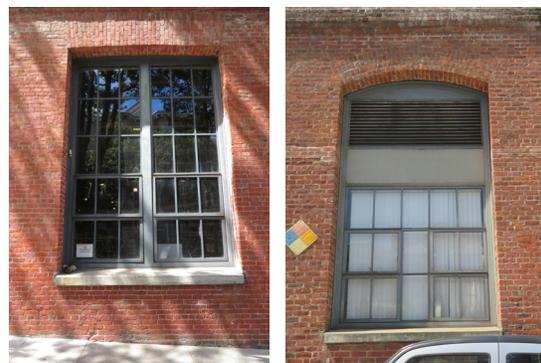
Ground-floor multi-lite steel windows

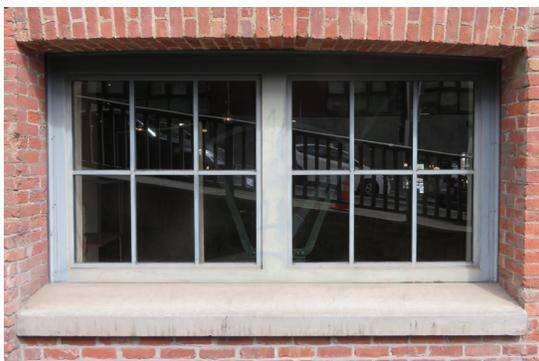
Multi-lite fixed window at the ground floor

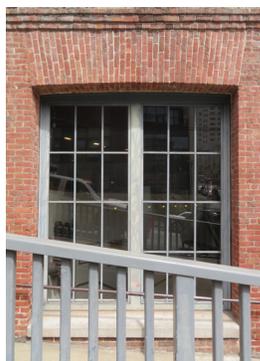
Multi-lite fixed window at the ground floor

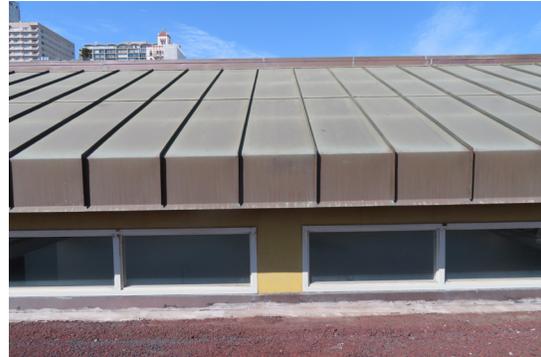
Steel awning windows at the clerestory

- Clean, adjust, or lubricate all sashes to make them easier to operate.
- Install new sealant at all windows and flashing.
- Prepare, prime, and paint all windows.
- Prepare, prime, and paint the plaster. Before painting, sound and replace all cracked and loose plaster. New plaster to match the texture of the existing plaster.

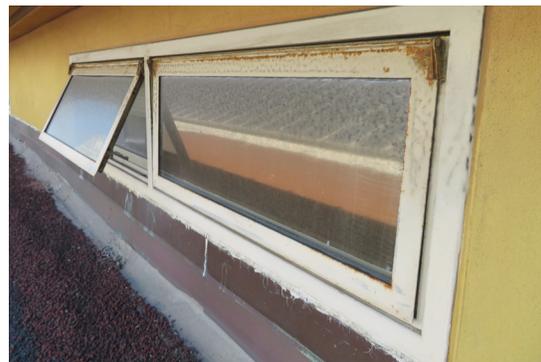
Steel awning windows

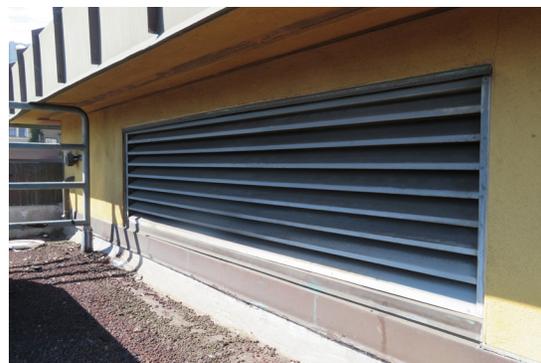
Sheet copper louver

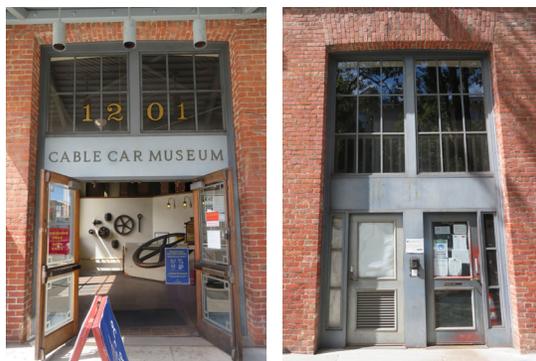
Museum entrance (left); east elevation doors (right)

- Clean, adjust, or lubricate all doors to make them easier to operate.
- Install new perimeter sealant at all door surrounds.
- Prepare, prime, and paint all metal door and entrance canopy components.
- Clean and refinish all wood doors.

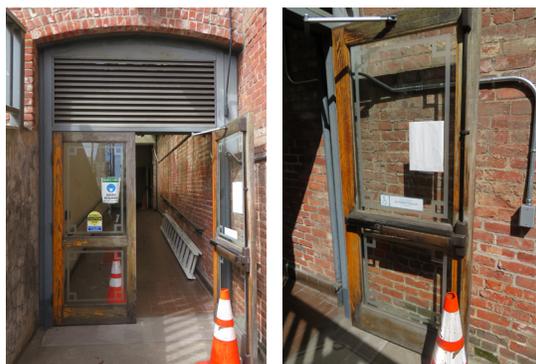
South elevation wood double doors

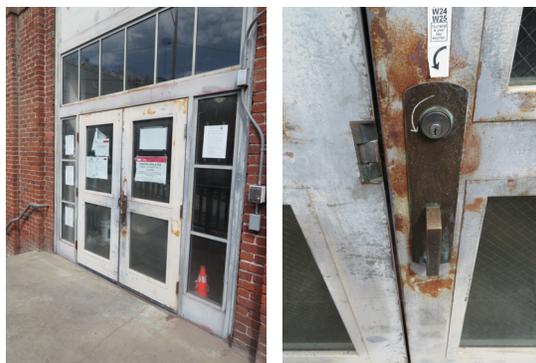
South elevation metal double doors

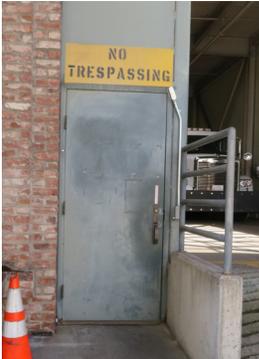
Flush metal door

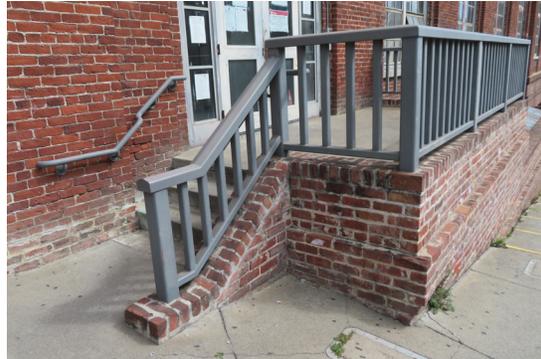
Steel railing, south elevation

- Prepare, prime, and paint the steel railing.
- Clean and refinish the bronze railing.

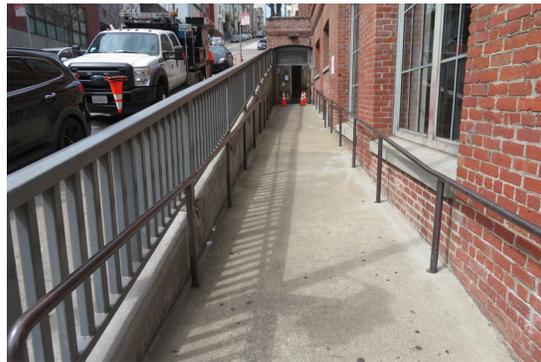
Steel and bronze railings, south elevation

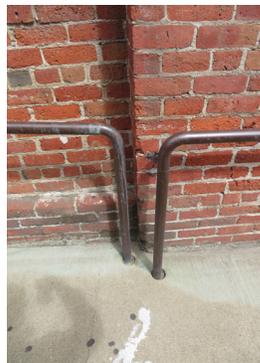
Bronze pipe railing, south elevation
